# LYNG CHURCH

Fredericia, Danmark

Roof: 2.000 m<sup>2</sup> 15 t Double Standing Seam RHEINZINK-prePATINA blue-grey

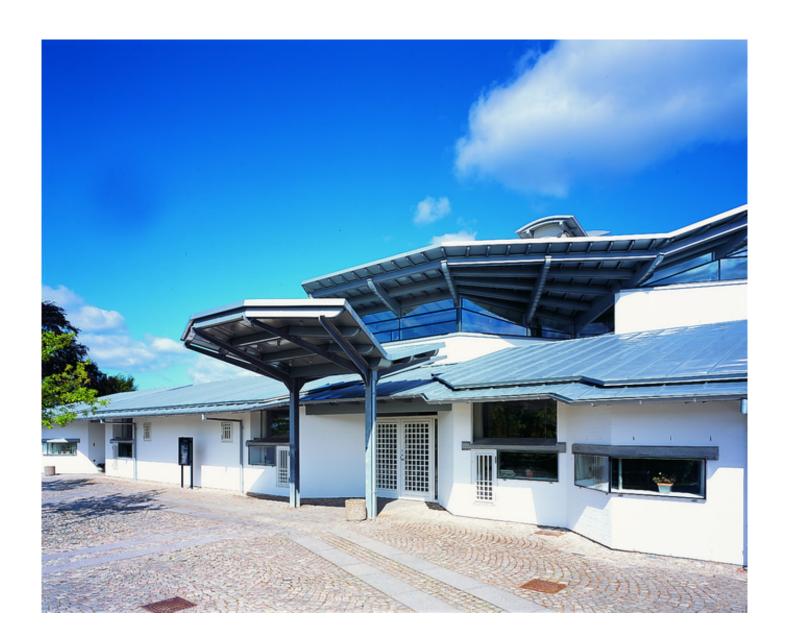
Some years ago, the roof of Lyng Church in the south of Denmark had to be restored. At that time the roofing - made of stainless steel, with defects in the joints and a very weather-exposed eaves construction with large glulam beams - took in water. As a result, the load-bearing structures in wood began to rot.

A new zinc cladding in the surface RHEINZINK prePATINA was mounted everywhere at an underlayer of 15 mm high, perforated zinc hat profiles due to extensive rot damage in roof ridges and roof edges. All rotten wood was replaced and painted before the zinc cladding was mounted. By mounting the perforated profiles, an 18 mm. ventilated cavity was ensured between the zinc cladding and the existing wooden structures.

To achieve an optimal airflow, the cladding on the back of all main girders, roof trusses and rafters is made of perforated zinc. The zinc overhang cladding is made with an air gap at all edges - also in perforated zinc. Perforation with a hole diameter of 3 mm. was chosen, as this hole size ensures that bees and other insects are not able to enter the ventilated cavities.
