LYNG CHURCH

Fredericia, Danmark

Roof: 2.000 m², 15 t, Double Standing Seam
RHEINZINK-prePATINA blue-grey

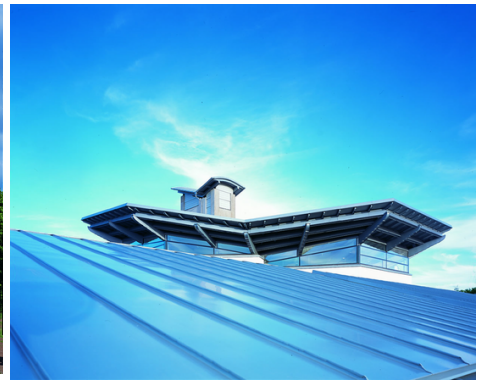
To achieve an optimal airflow, the cladding on the back of all main girders, roof trusses and rafters is made of perforated zinc. The zinc overhang cladding is made with an air gap at all edges - also in perforated zinc. Perforation with a hole diameter of 3 mm. was chosen, as this hole size ensures that bees and other insects are not able to enter the ventilated cavities.

A new zinc cladding in the surface RHEINZINK prePATINA was mounted everywhere at an underlayer of 15 mm high, perforated zinc hat profiles due to extensive rot damage in roof ridges and roof edges. All rotten wood was replaced and painted before the zinc cladding was mounted. By mounting the perforated profiles, an 18 mm. ventilated cavity was ensured between the zinc cladding and the existing wooden structures.
