VACATION HOME GERMANY

Niederzissen, Tyskland

Roof renovation with RHEINZINK GRANUM basalte

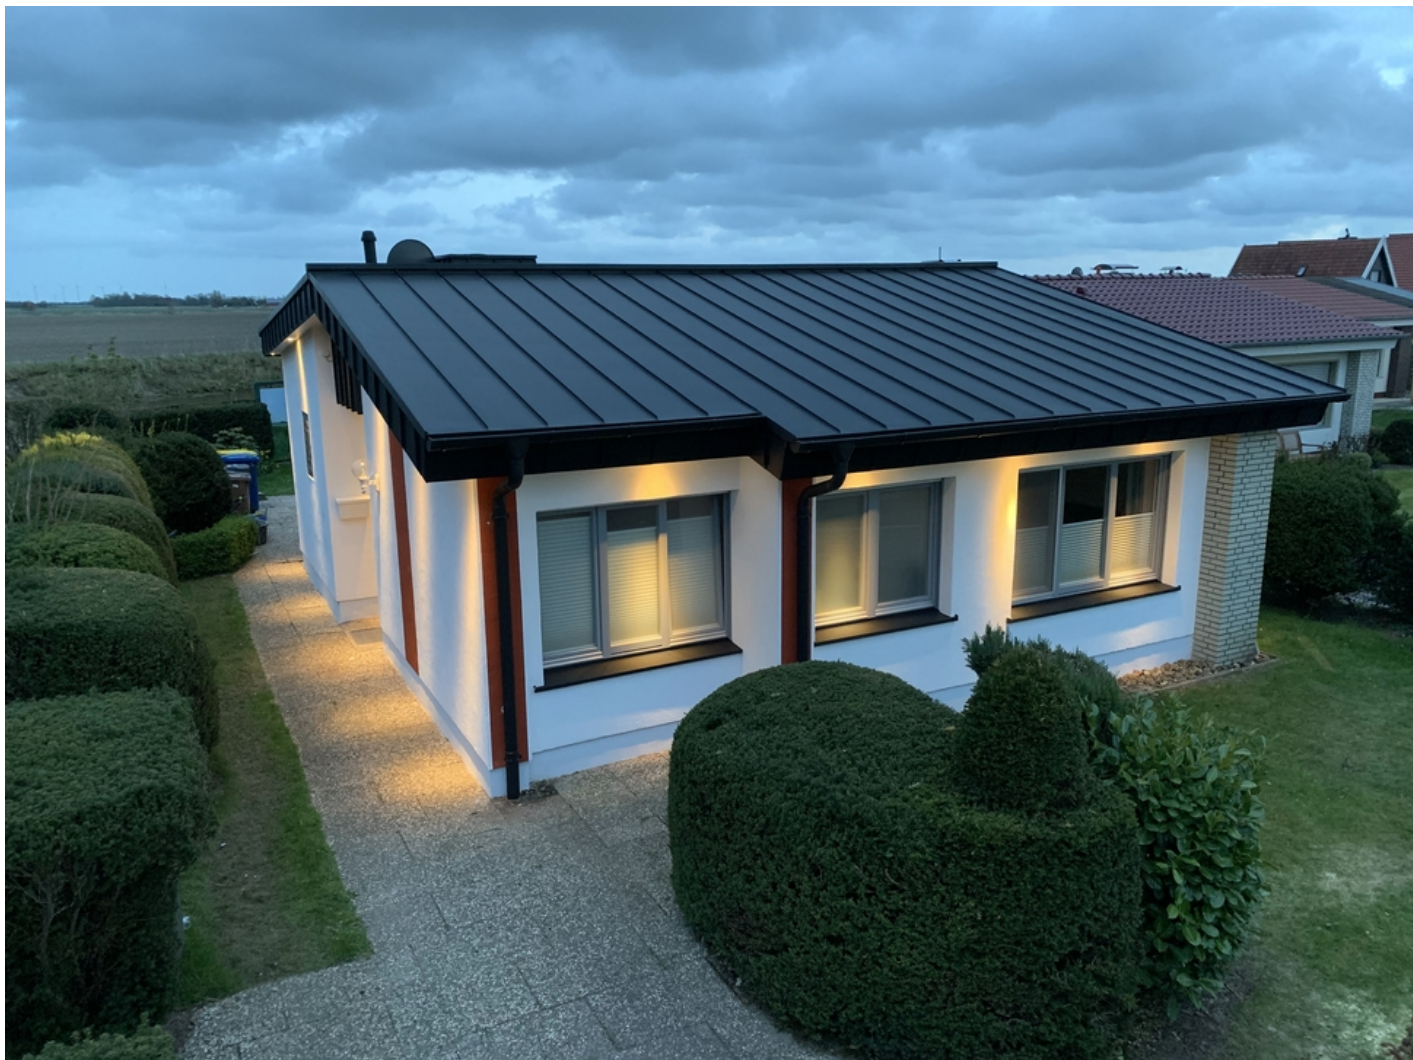
Roof: Double Standing Seam
RHEINZINK-GRANUM basalte

Roof Drainage:
RHEINZINK-GRANUM basalte

For the metal roof of a holiday home, the roofer used the new surface quality RHEINZINK GRANUM basalte for the first time. The carefully adapted roof layout and the precise roof division emphasise the noble appearance of the matt and deep dark material.

The holiday home of the Keuler family of roofers and plumbers was built in the early 1970s in the bungalow style and a roof covering typical of the time with the Berlin wave. Minor storm damage, defective gutters and the first leaks now required renewal. Besides, a roofer's house should look decent at all times, as Stefan Keuler emphasises. Of course, this also applies when, as in this case, there are about 450 km between the holiday home and the company's headquarters in Niederzissen, Rhineland-Palatinate. It was there in 1961 that Stefan Keuler's grandfather founded the company that today operates as Lehmann GmbH Meisterbetrieb für Bedachung und Klempnerei. It was precisely because of this dual range of services and because of the low pitch of the roof that it made sense to re-roof the holiday home as a metal roof.
